LOCKOUT/TAGOUT PROCEDURE
OSHA CFR 1910.147

Developed by	Reviewed by	Revised by
RA	RA	
Description: Chiller 3		Equipment #: N/A
Building: North Chill Water Plant	Area: North Chill Water Plant	Rev: 0
Date: N/A	Origin Date: 12/18/2017

Isolation Points to be Locked and Tagged	CAUTION
		Steam Absorption Chiller. Pressurized refrigeration loop to be serviced by authorized personnel only.

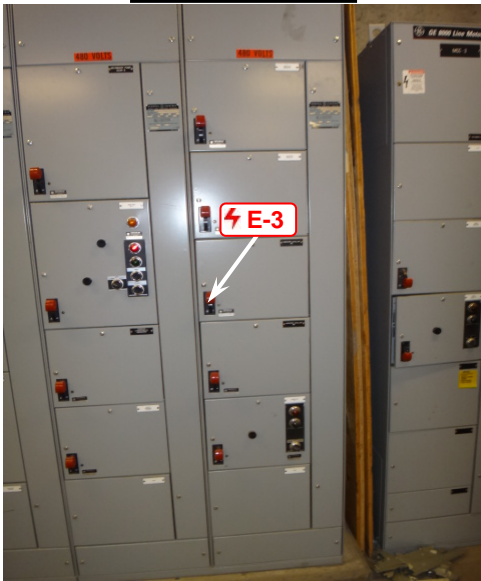
East Side View

Electrical 480V	Padlock	Isolation point located on panel MCC-1.	Move electrical disconnect "Absorption Chiller #3" to off. Lock out.	Attempt restart at CP-3.

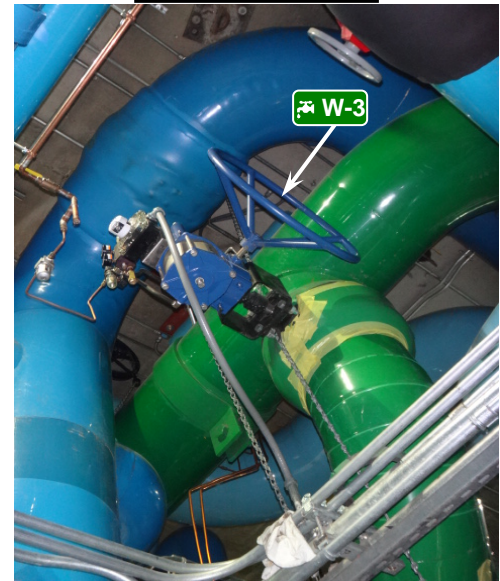
North Side View

Condenser Water Outlet - 40 PSI	Cable device	Isolation point on North side of unit.	Turn valve to closed position. Lock out.	Visually verify zero pressure status.
	Thermal Energy 300 F
