Re: Informational Letter
Hydrogeologic Investigation
Dartmouth College, Rennie Farm Site
DES Site No. 201111109, DES Project No. 277737

RENNIE FARM SITE HISTORY

**DARTMOUTH COLLEGE, RENNIE FARM SITE
HANOVER, NEW HAMPSHIRE
NHDES SITE NO. 201111109, PROJECT NO. 277737**

SITE FEATURES PLAN

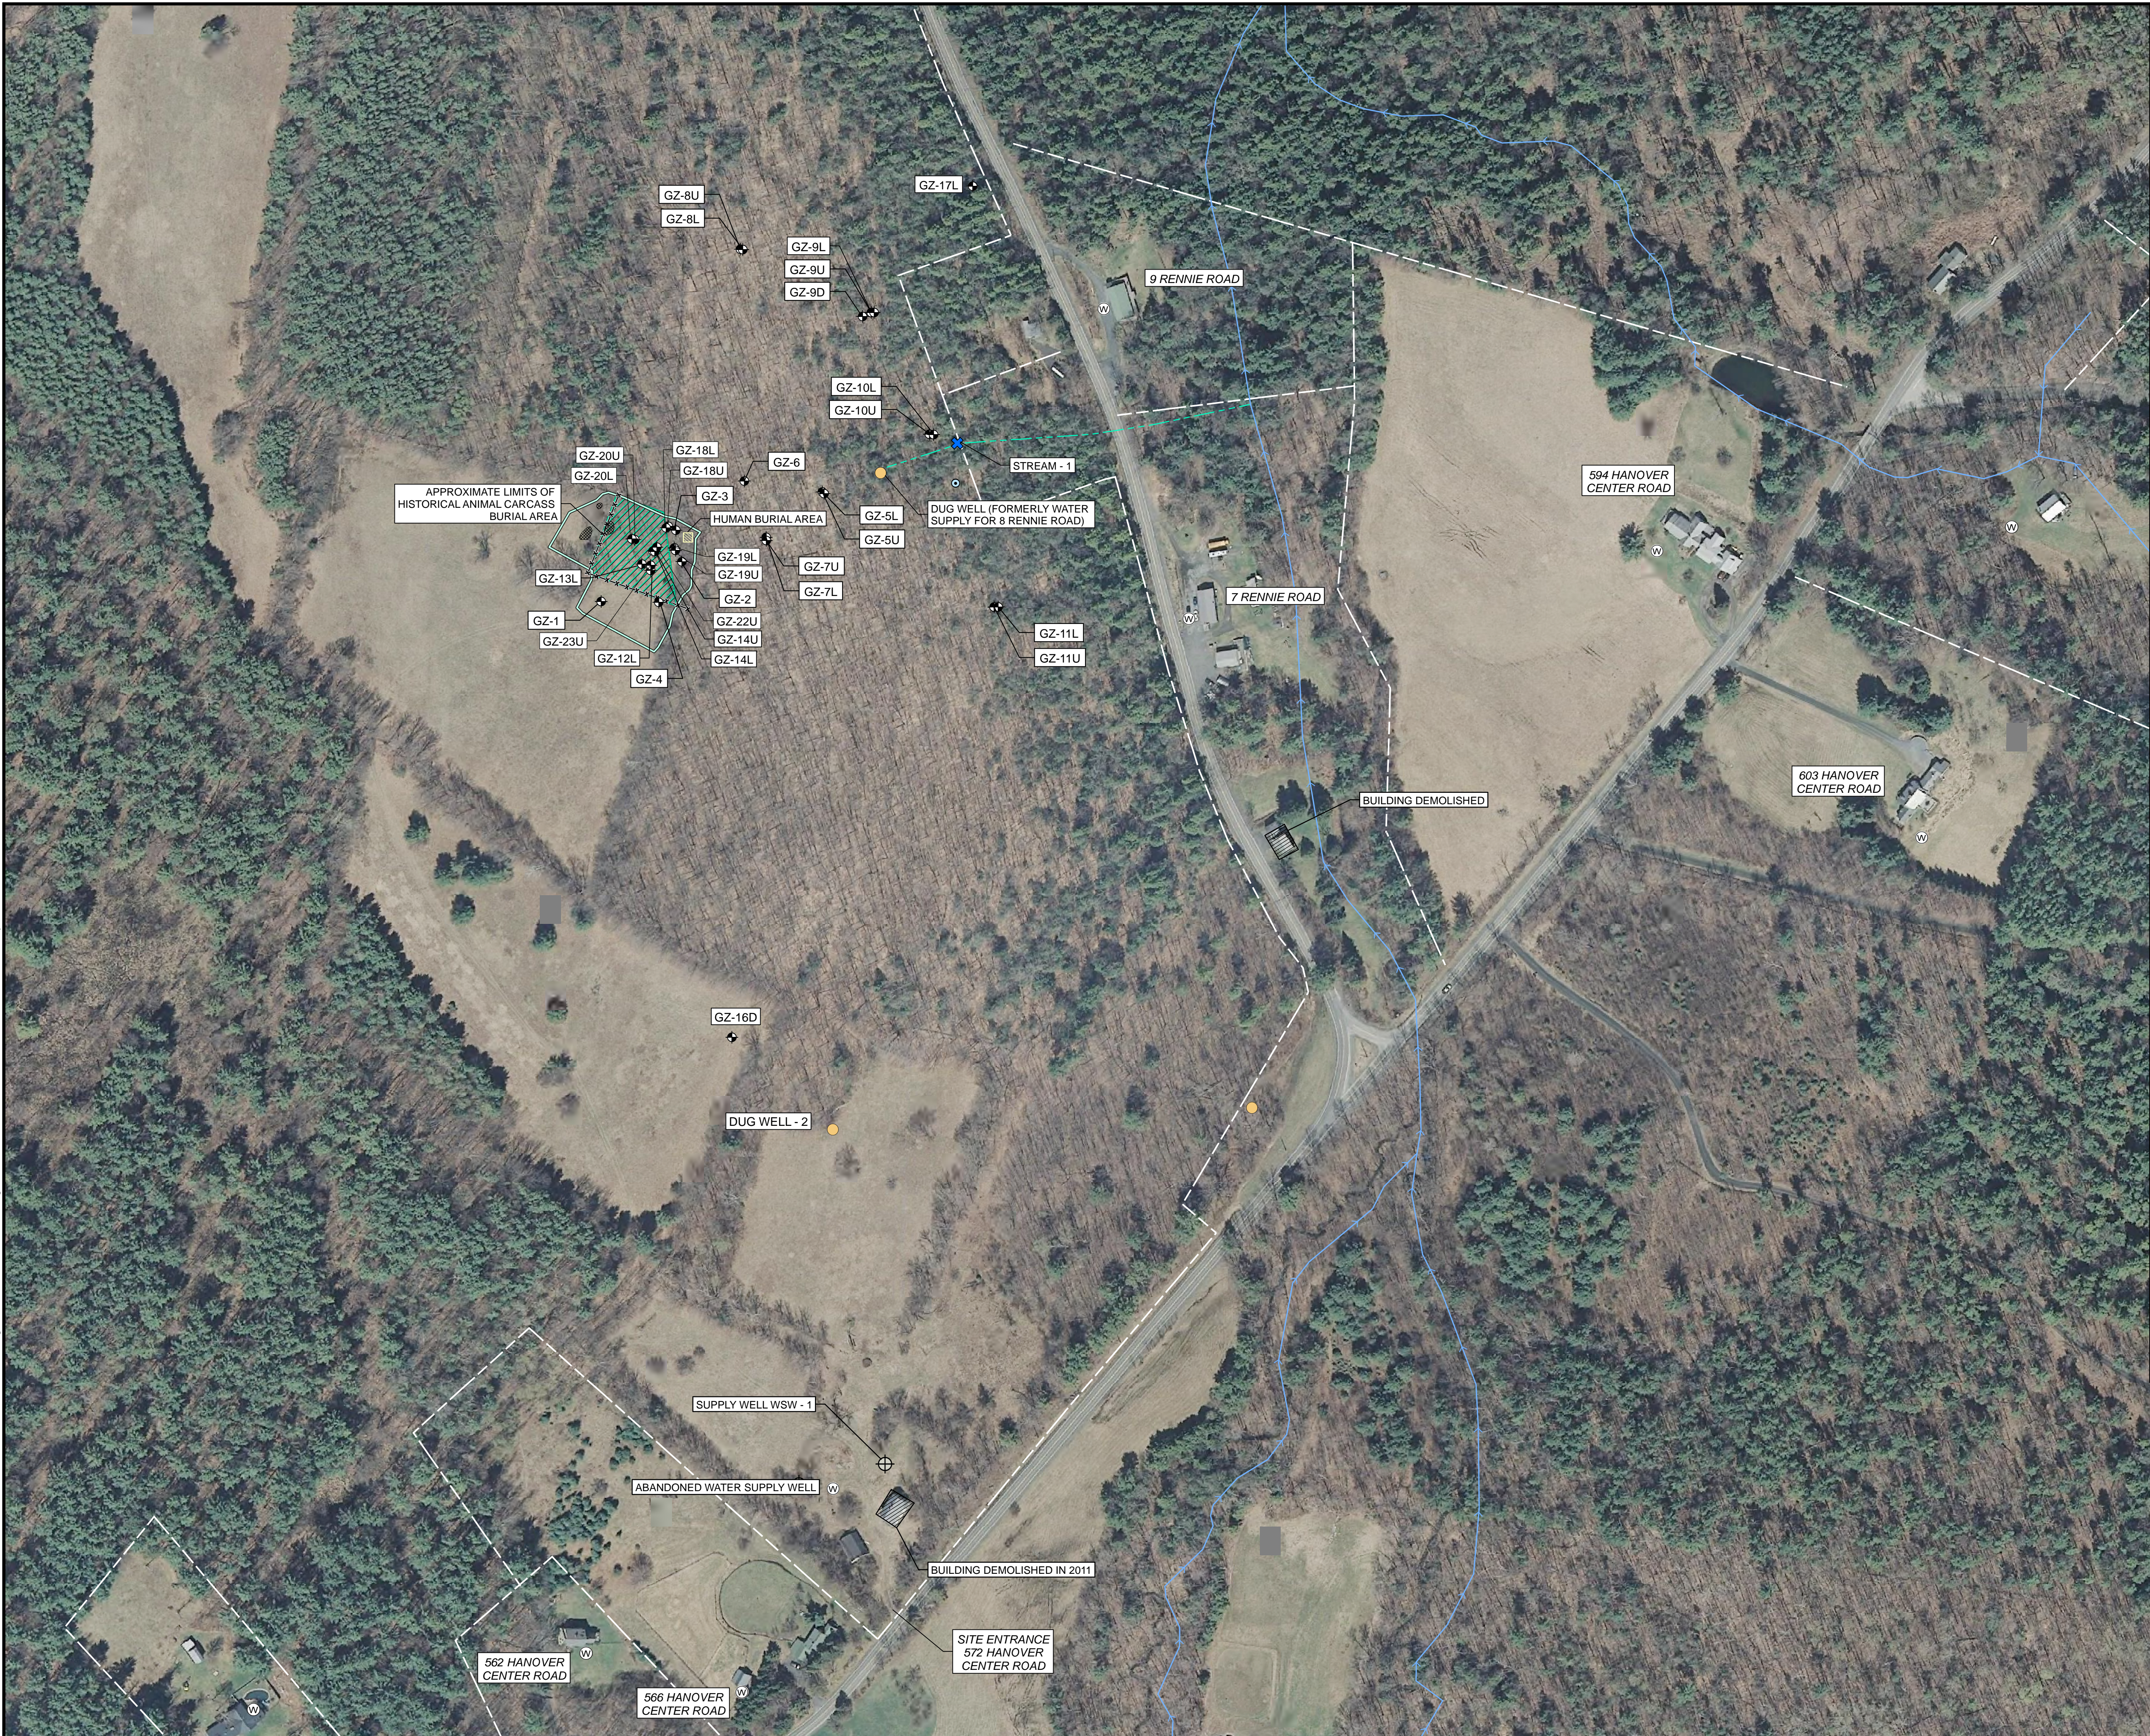
A history of the Rennie Farm property relevant to the investigation and a figure illustrating the locations of features referenced in the history are attached. From the mid-1960s to 1978, a less than ½-acre portion of the Rennie Farm was used by Dartmouth as a State-licensed burial site for animal remains used in laboratory research. This burial area was excavated and remediated in 2011, and groundwater monitoring has been ongoing since that time under the review and approval of DES.
